**TEST AND EVALUATION OF AN EXPERIMENTAL FEASIBILITY
PROTOTYPE PASSIVE SEAT MOUNTED LIMB RESTRAINT SYSTEM**

Marcus Schwartz
Aircraft and Crew Systems Technology Directorate
NAVAL AIR DEVELOPMENT CENTER
Warminster, Pennsylvania 18974

20 May 1981

PHASE REPORT
AIRTASK NO. 1F41-400-000
Work Unit No. ZA61D
Program Element No. 62241N

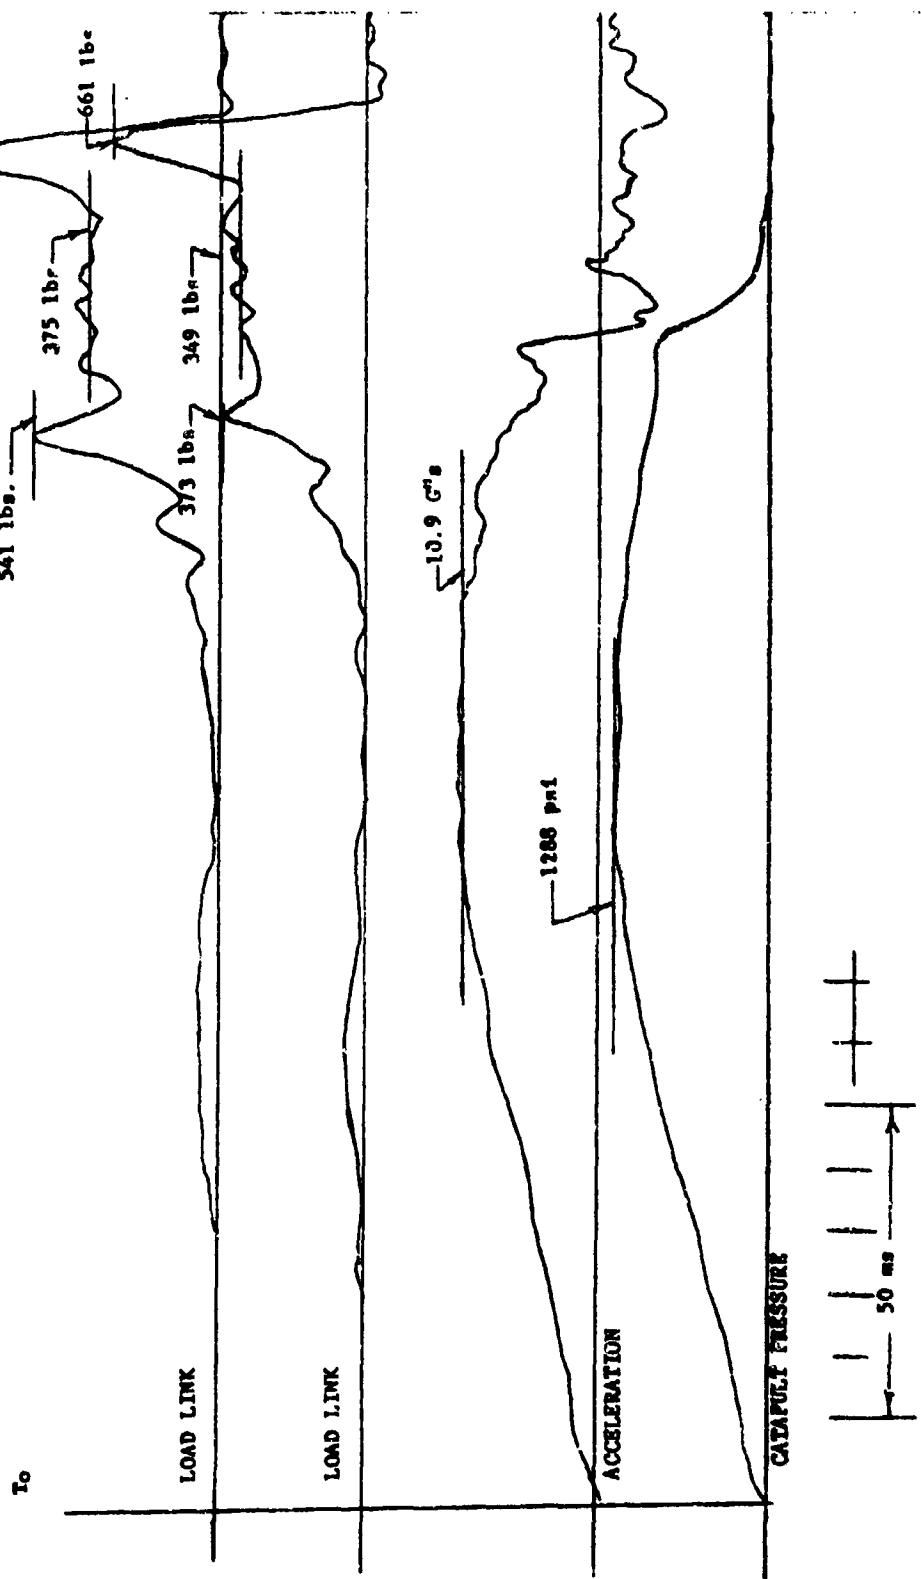
FIGURE 3 - Oscillograph Record - Ejection Test No. 1

The original intention was to conduct only four ejection firings to evaluate the leg entrapment and cinching function. Due to a repeated failure of the one way snubber mechanism, it was necessary to fire 4 preliminary tests with the 5th percentile dummy set-up to obtain a satisfactory redesign and positioning of the snubber on the seat. Although each of the first four tests resulted in successful entrapment of the legs during the initial phase of the ejection, as required, the failure of the snubber mechanism resulted in inappropriate tensioning of the restraint lines and caused a no-test condition since the overall restraint line performance could not be evaluated. Figure 3 shows a trace typical of the first four tests.

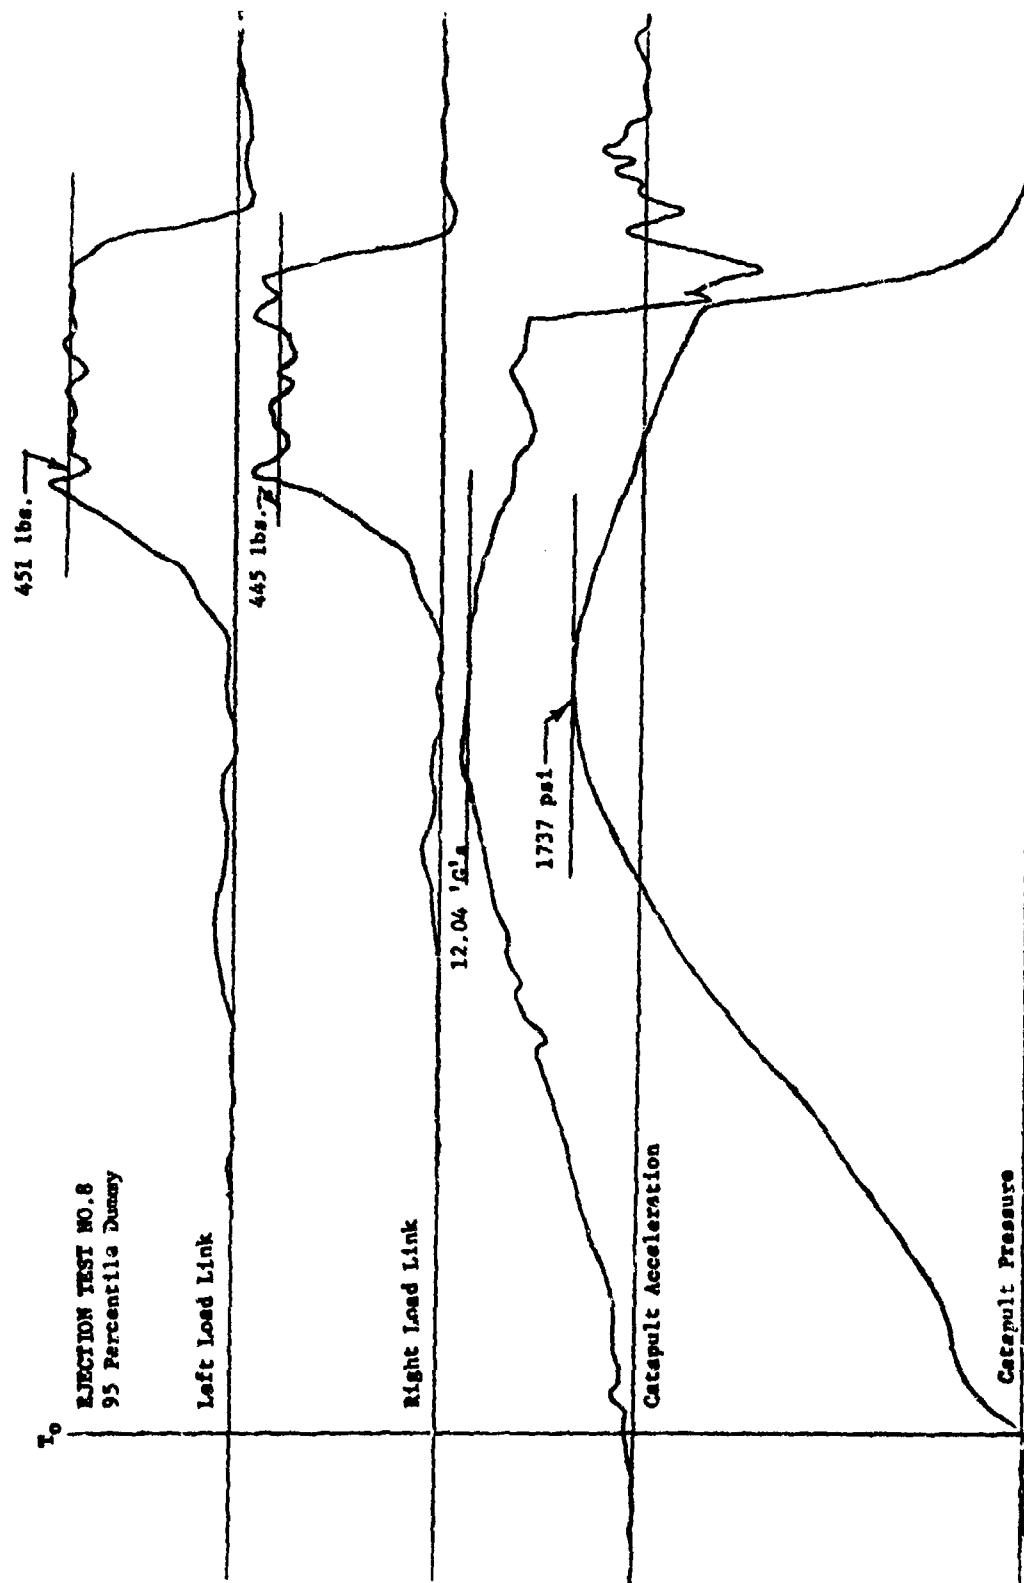
FIGURE 12 - Oscillograph Record - Test No. 8

Tests number 8 and 9 were also totally successful and were identical to test No. 7. The test records are shown in figures 12 and 13. Complete entrapment and tensioning through the locking snubber proved to be satisfactory.

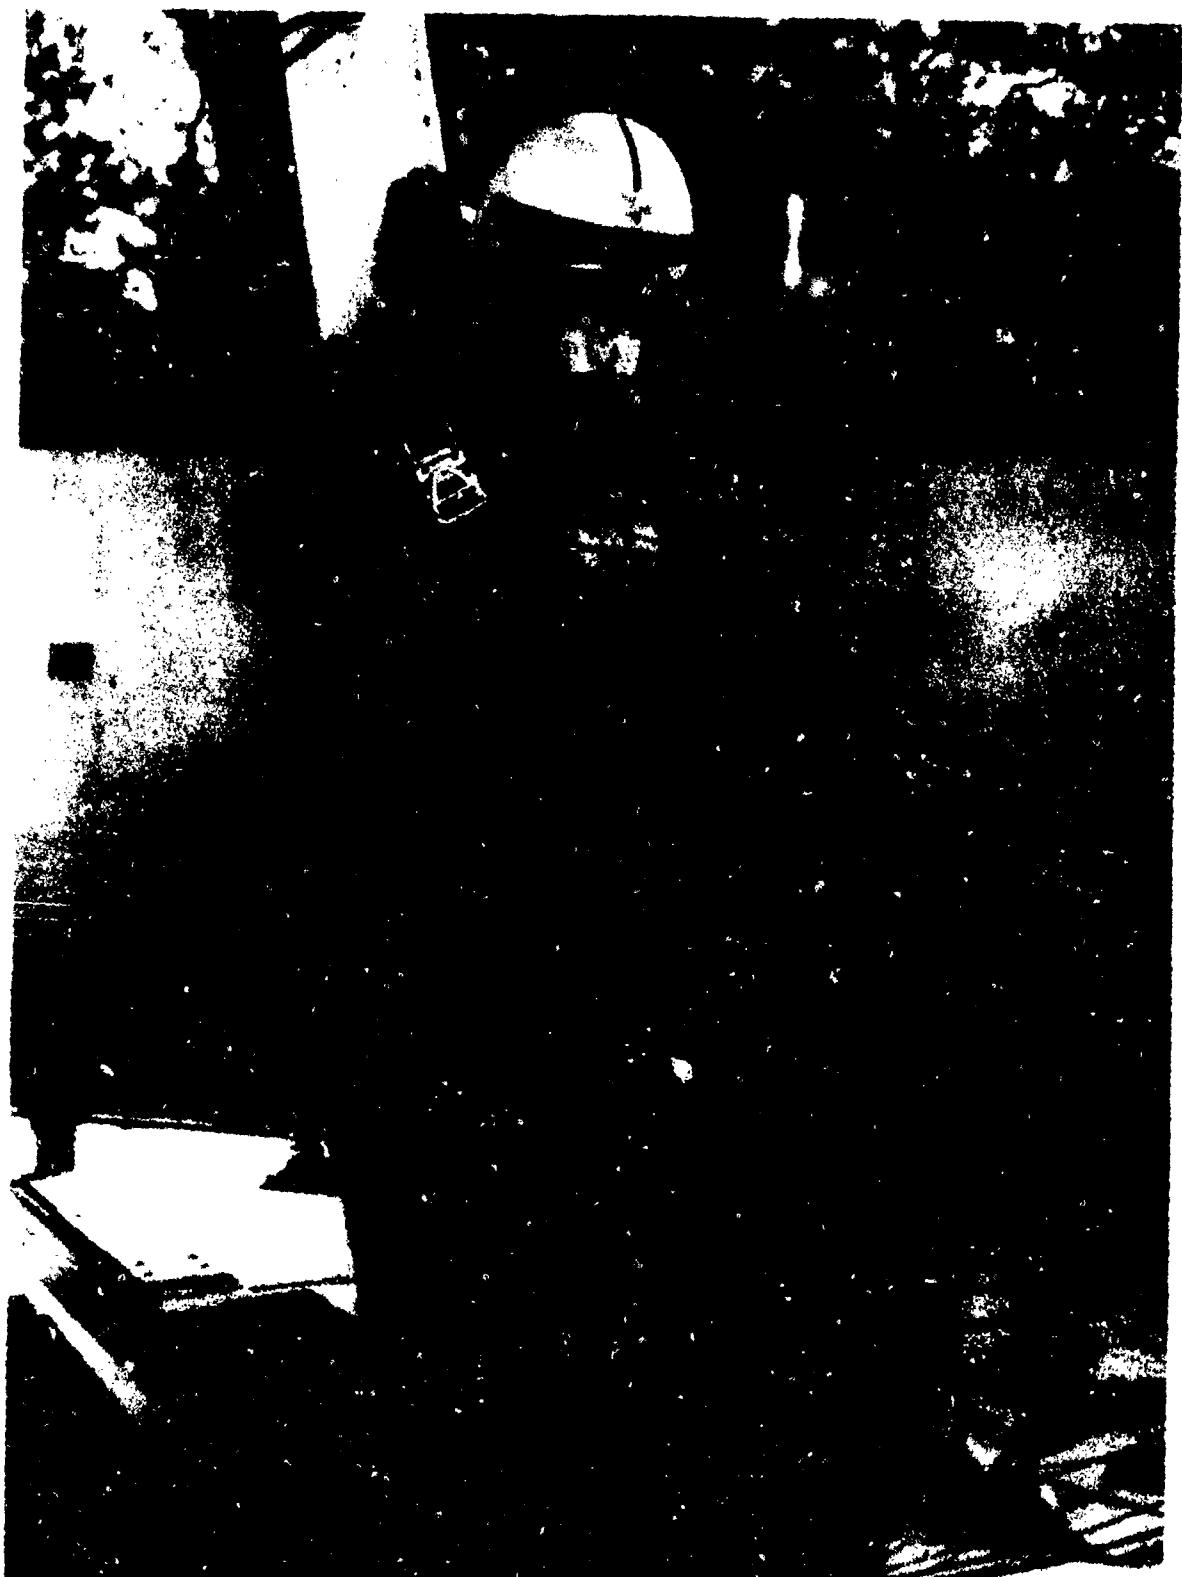
FIGURE 19 - Windblast Test Set-Up - Yaw 45 Degrees Starboard

For this test, the seat was replaced in the original 17 degrees aft of vertical and then first yawed 45 degrees to the starboard side (figure 19). The system was then subjected to a 420 knot windblast exposure. Again, the limbs were satisfactorily restrained.

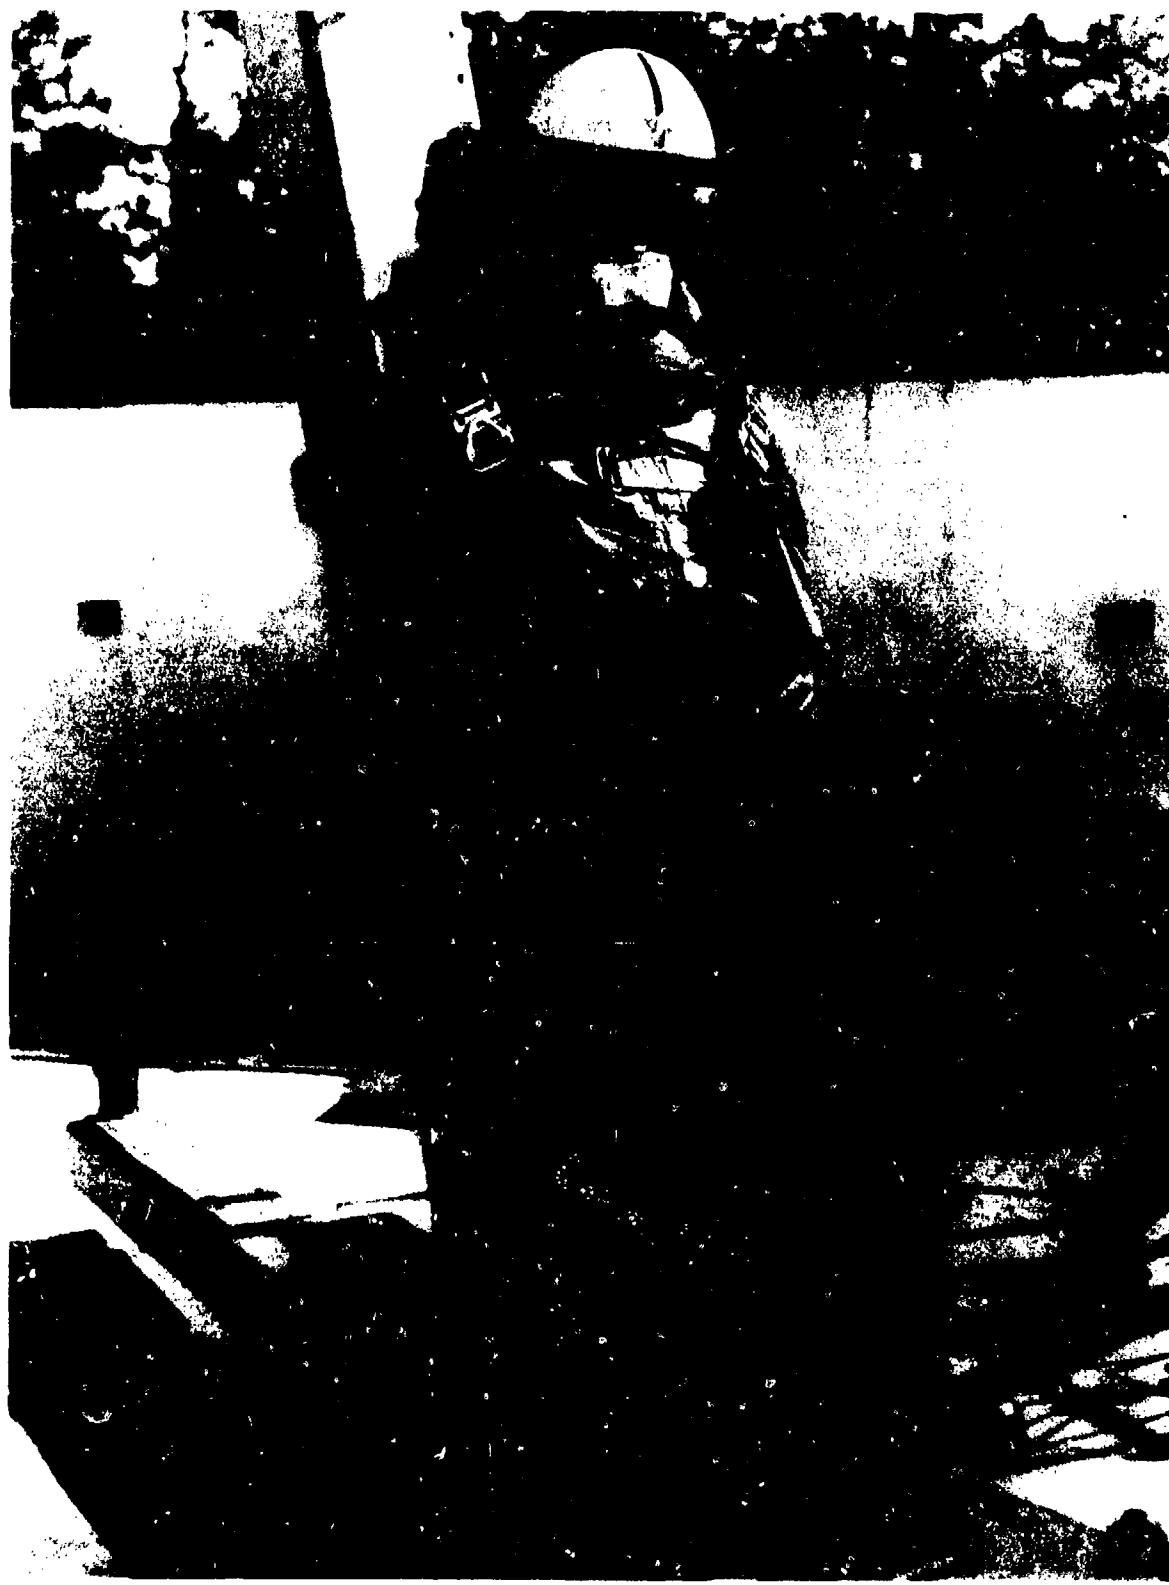
FIGURE 20 - Post Test Condition - Yaw 45 Degrees Starboard

The only motion observed was the slight movement of the dummy's legs in the direction of the windblast, as would be expected, but still adequately restrained (figure 20). The test was repeated on the port side with similar successful results.

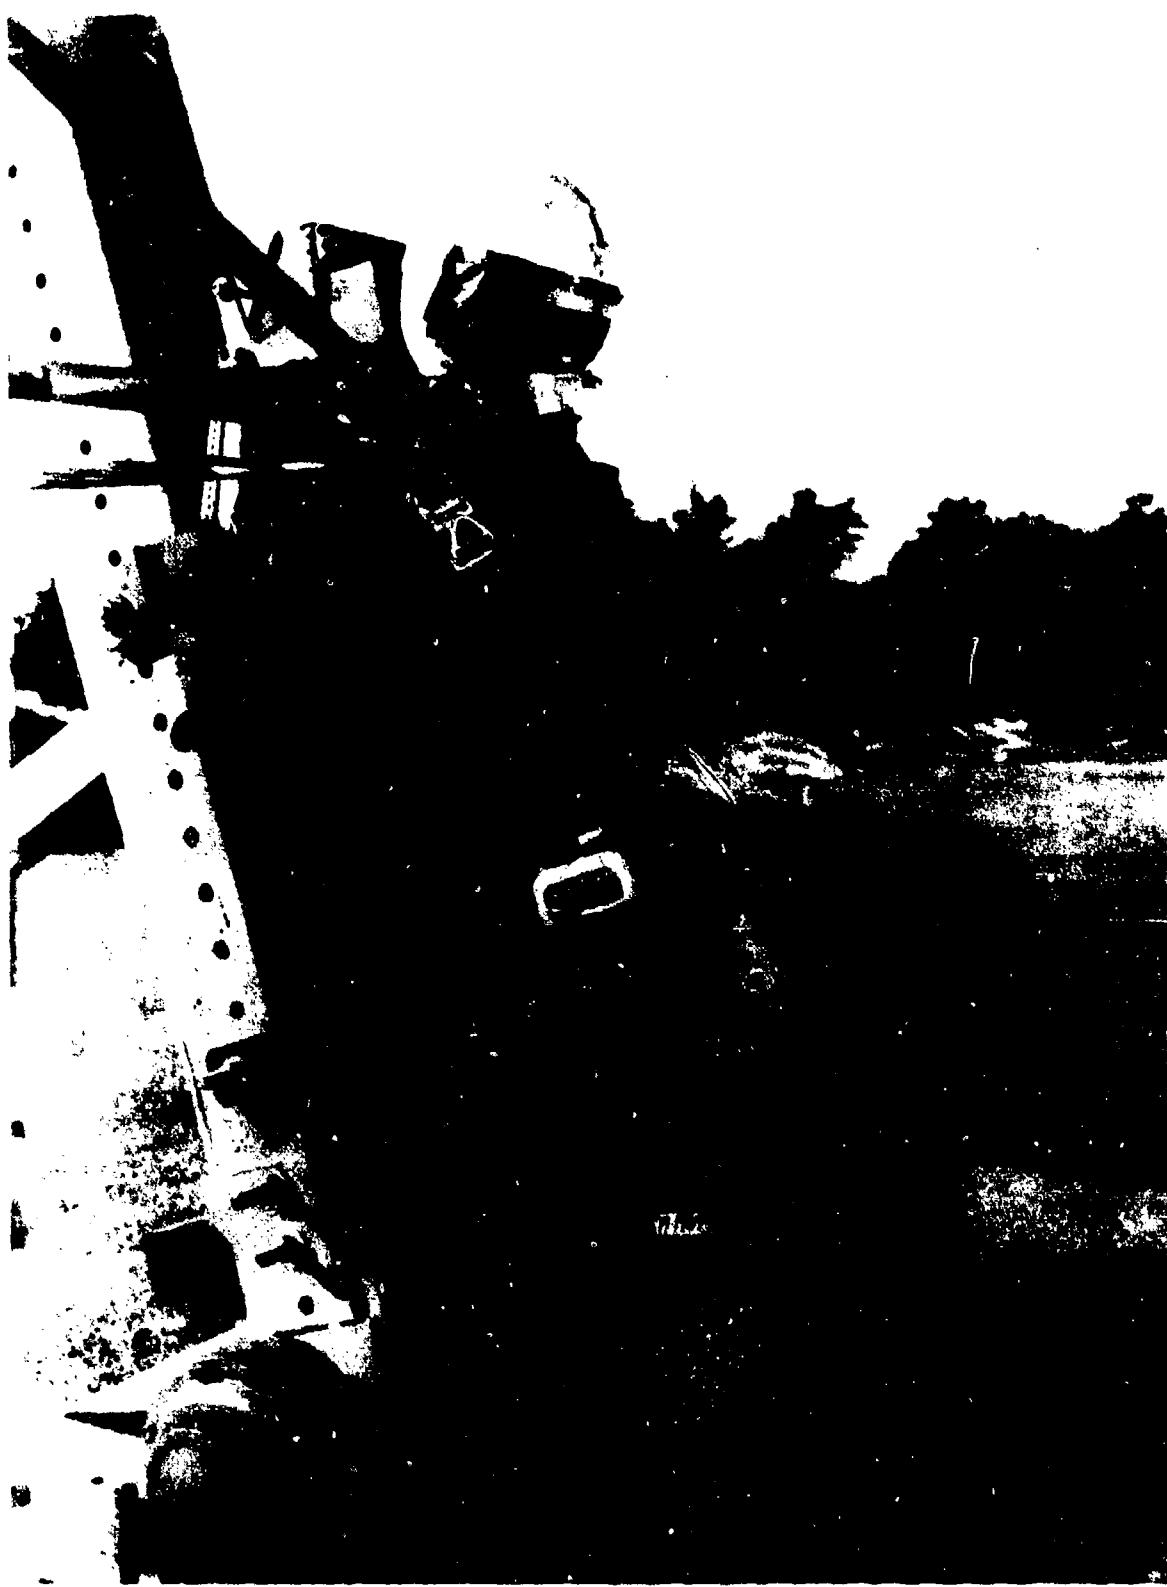
FIGURE 21 - Windblast Test Set-Up - Yaw 90 Degrees Port

Following the successful 45-degree yaw test, the seat was rotated to a full 90-degree yaw position relative to the air nozzles (figure 21).

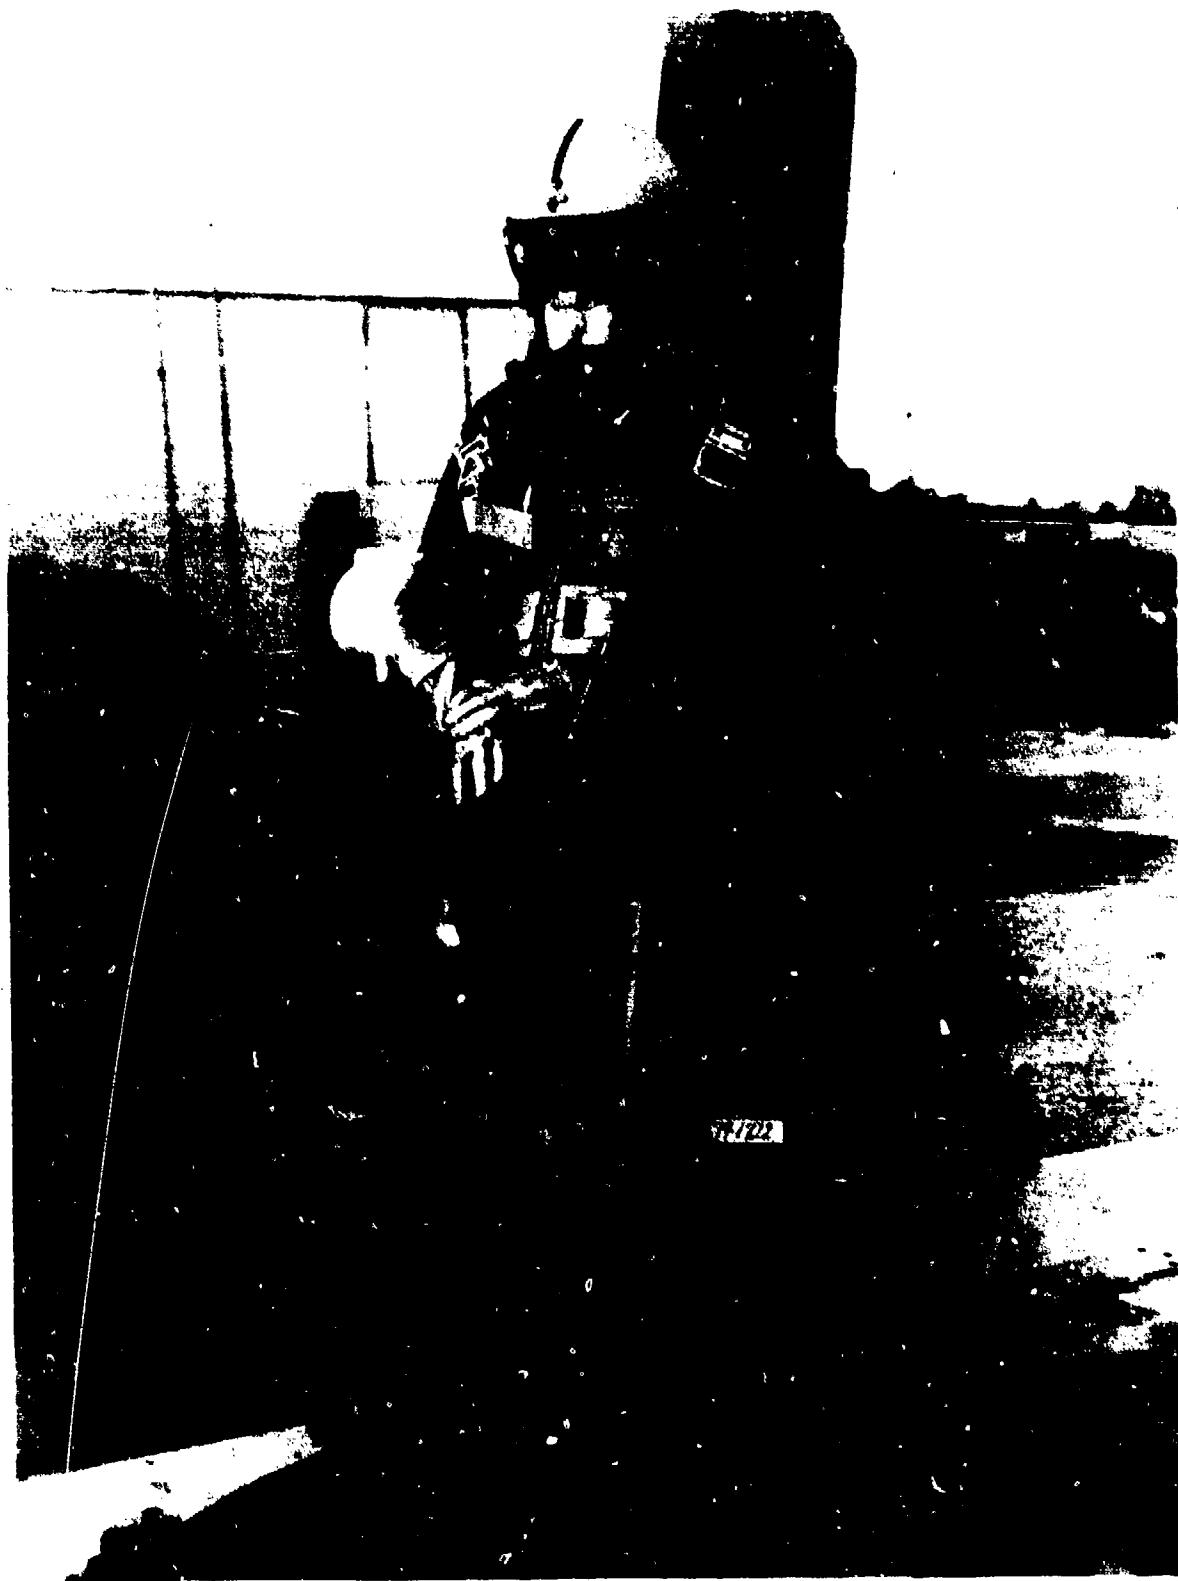
FIGURE 23 - Windblast Test Set-Up - 45 Degree Yaw - 537 Knots

The seat was positioned again at 45 degrees yaw to the port side (figure 23).

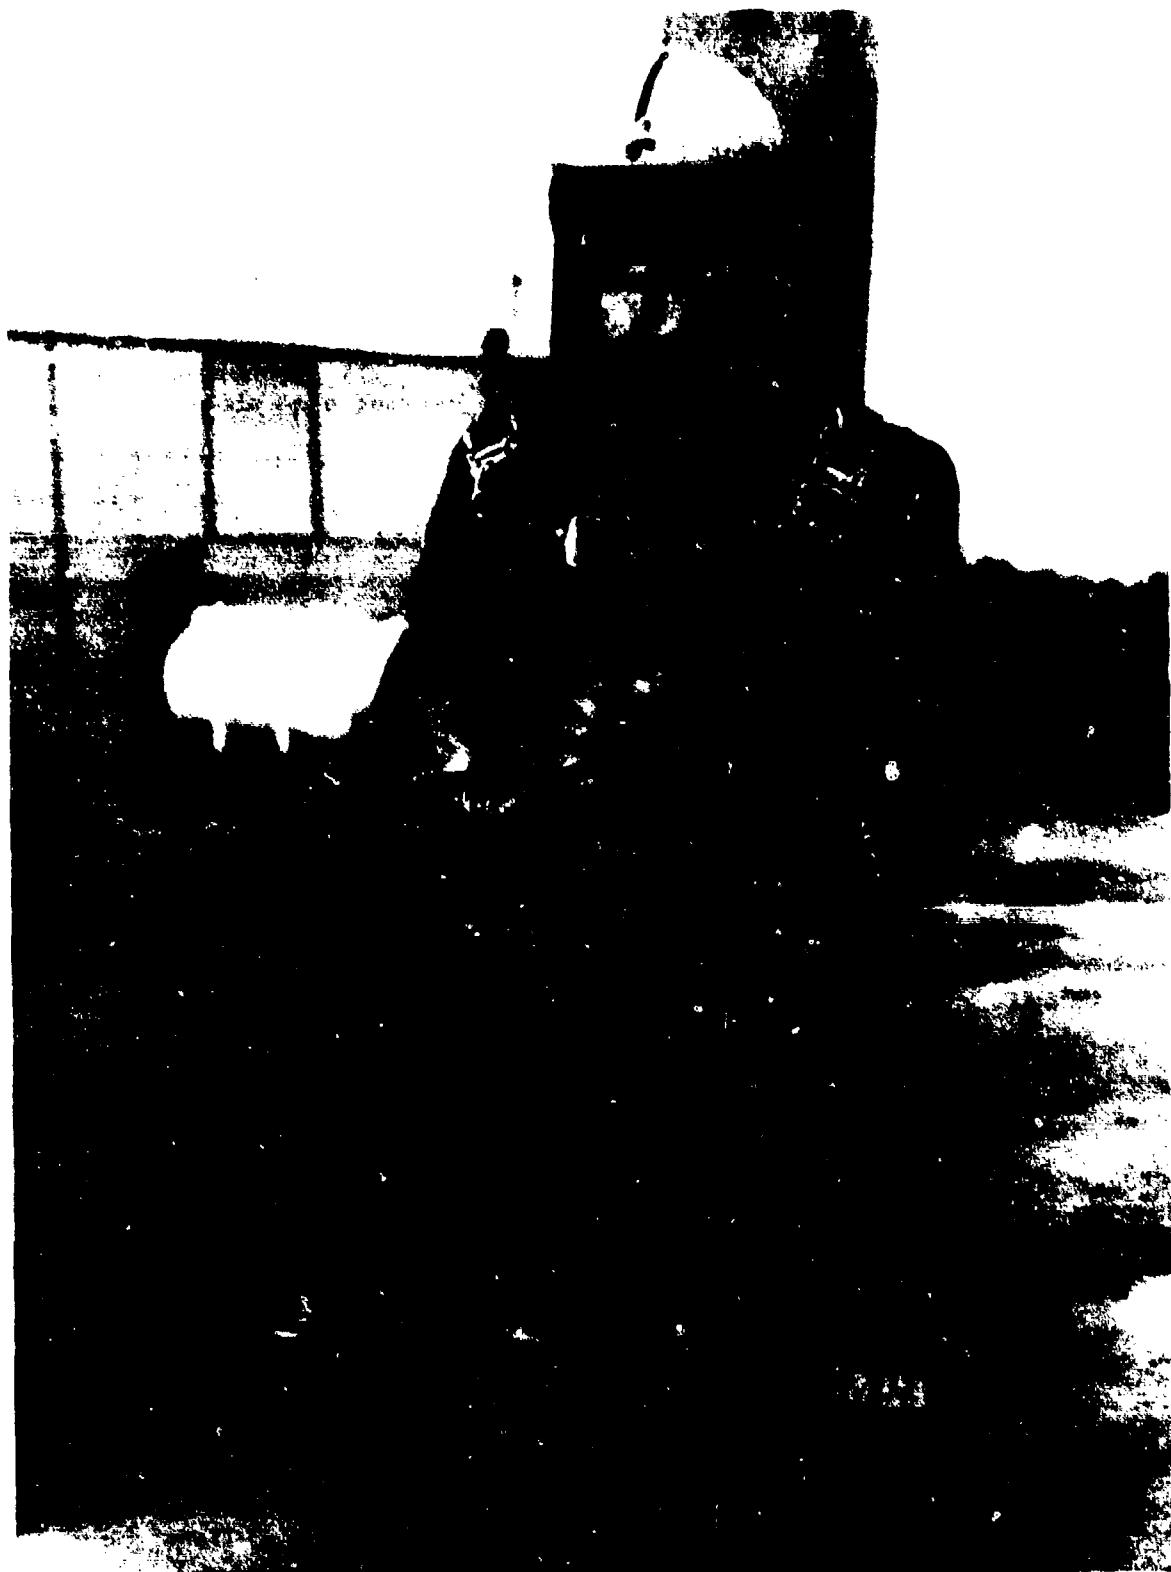
FIGURE 24 - Post Test Condition - 45 Degree Yaw - 537 Knots

After resetting the strap tension loads in the leg lines, the system was subjected to a 550-knot windblast exposure. The system was examined immediately after the test and the dummy's limbs were found to be perfectly restrained and secured in the ejection position. Subsequent analysis of the high-speed film coverage confirmed the adequacy of the restraint configuration to protect and secure the limbs for this condition. As before, the only motion in the dummy was some slight sideways motion of one leg in the direction of the windblast (figure 24).

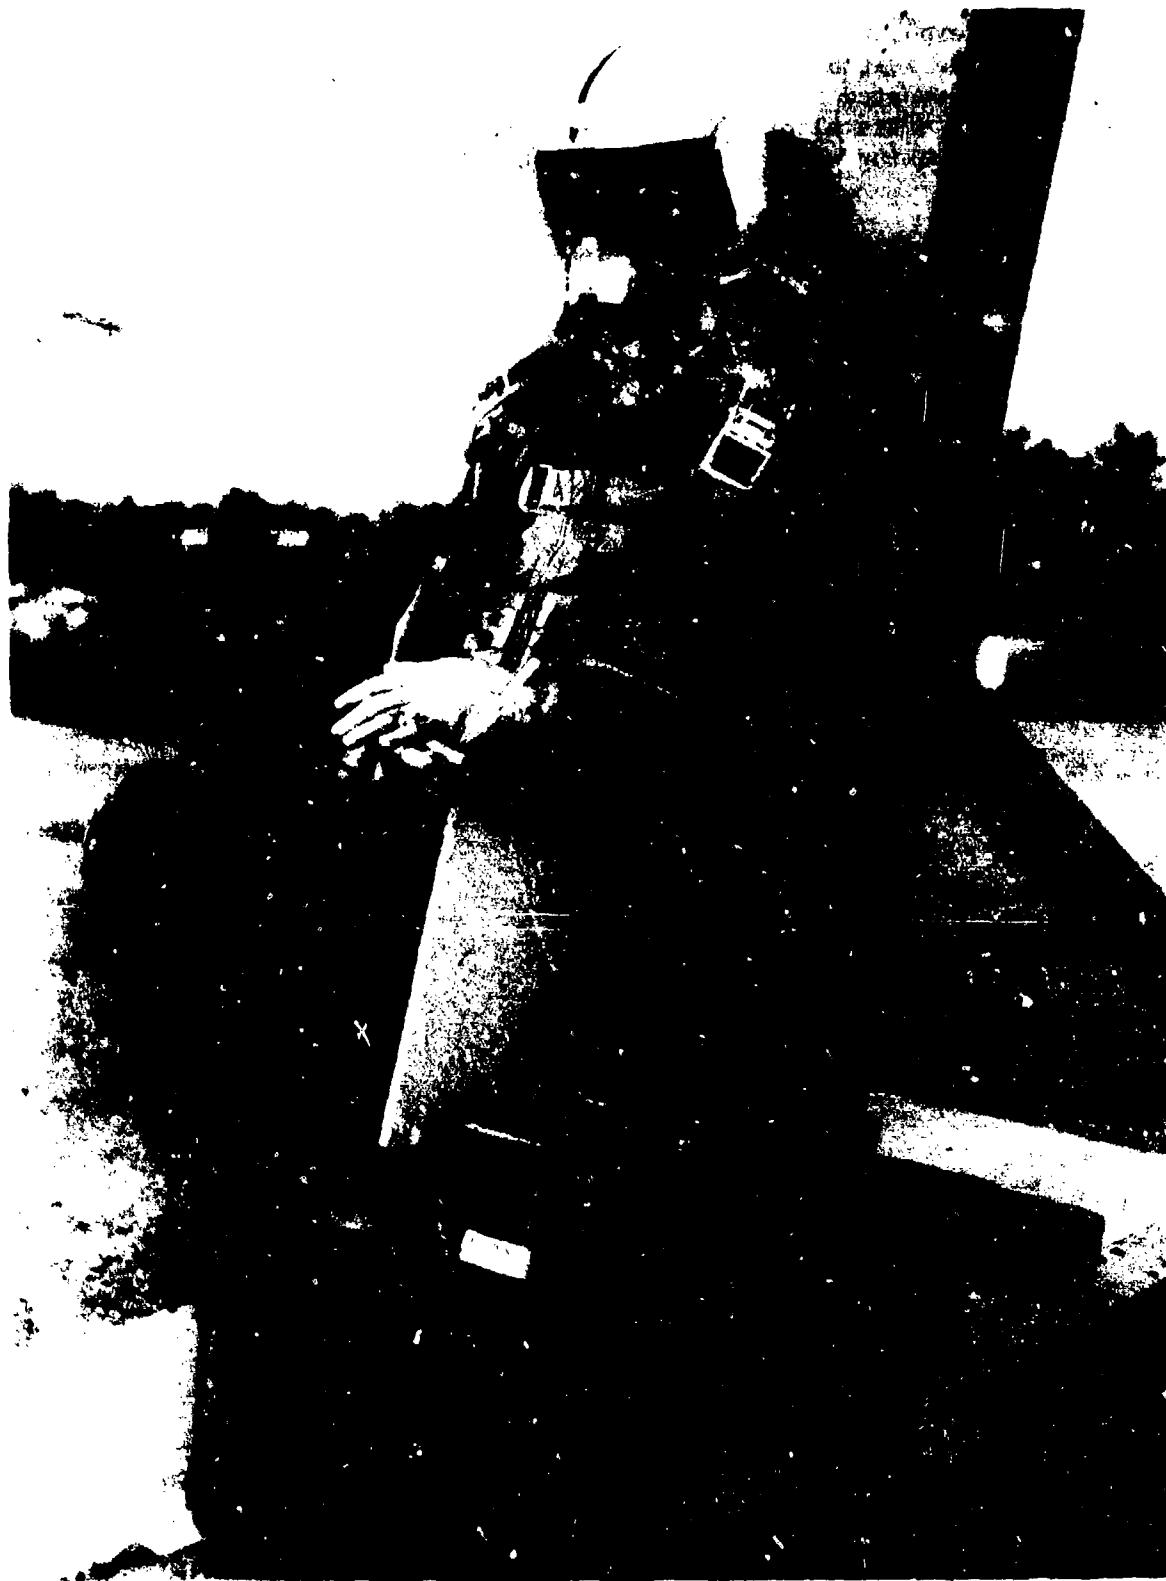
FIGURE 25 - Windblast Test Set-Up - Head - On 605 Knots

The final test of the windblast series was a 600K level exposure. The seat was positioned at the nominal 17-degree seat back angle and straight ahead to the windblast direction (figure 25). As before, the restraint line tension loads were checked prior to the test. The right hand line was easily tensioned to the 400-lb. level and locked via the snubber. The left hand restraint line was also tensioned to the 400-lb. level, but it was not readily locked in place via the snubber when the applied tensioning load was released. The snubber was only able to be locked after some slippage of line as the load was being released. After several unsuccessful attempts to lock the snubber at the 400-lb. load level, it was necessary to allow the snubber to lock at a lower level, (which was not observable) but was estimated at about 300 lbs.

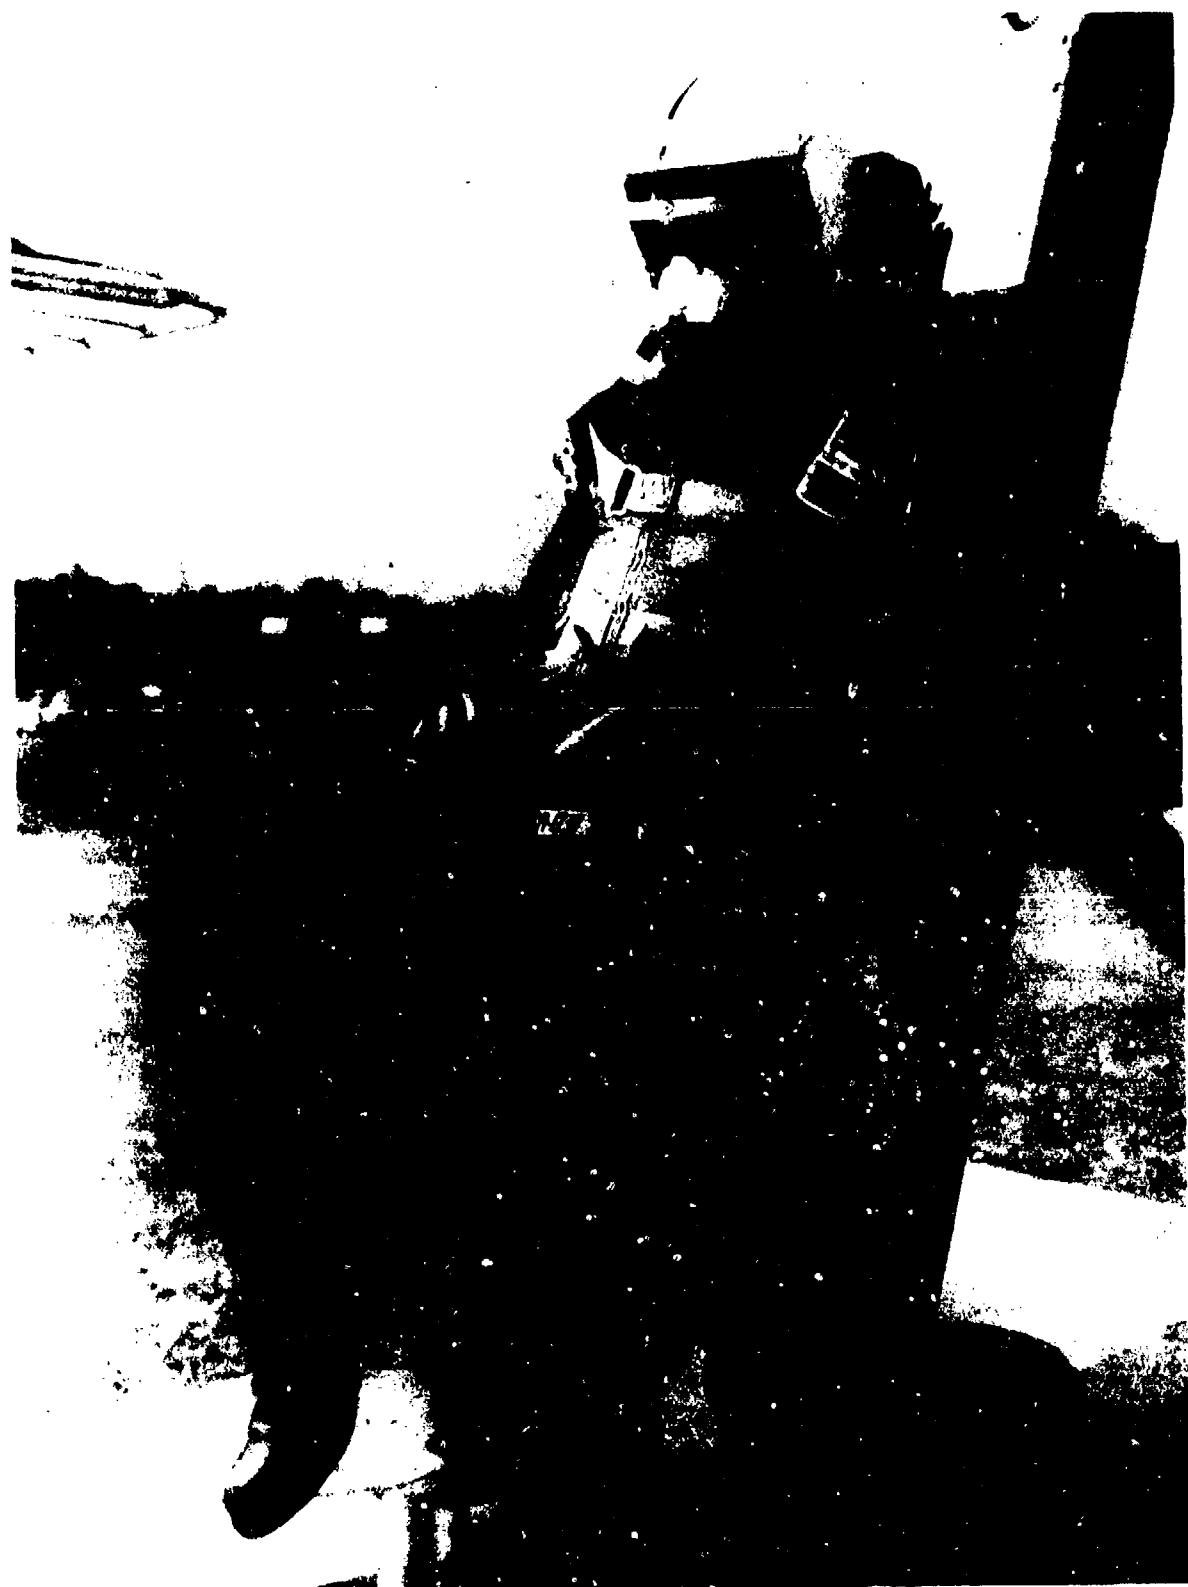
FIGURE 26 - Post Test Condition 605 Knots Port Side

At peak exposure, the dummy's left arm translated down approximately parallel to the seat back (figure 26), but was still entrapped by the arm net. The arm was prevented from flailing. The obvious reason for this arm motion was due to the extra slack allowed in the restraint line because of the problem with locking the snubber at the 400-lb. load level.

It should be noted that with slight modification to this feasibility prototype, it is possible to assure total arm retention and protection against flailing, despite slack in the system and hence, eliminate large variations in tension loads, as a critical element in system reliability and performance. The results of the test and evaluation of the windblast testing phase were considered highly successful and extremely encouraging. The information obtained from the overall test and evaluation study will provide the basis for the development of an advance prototype model.

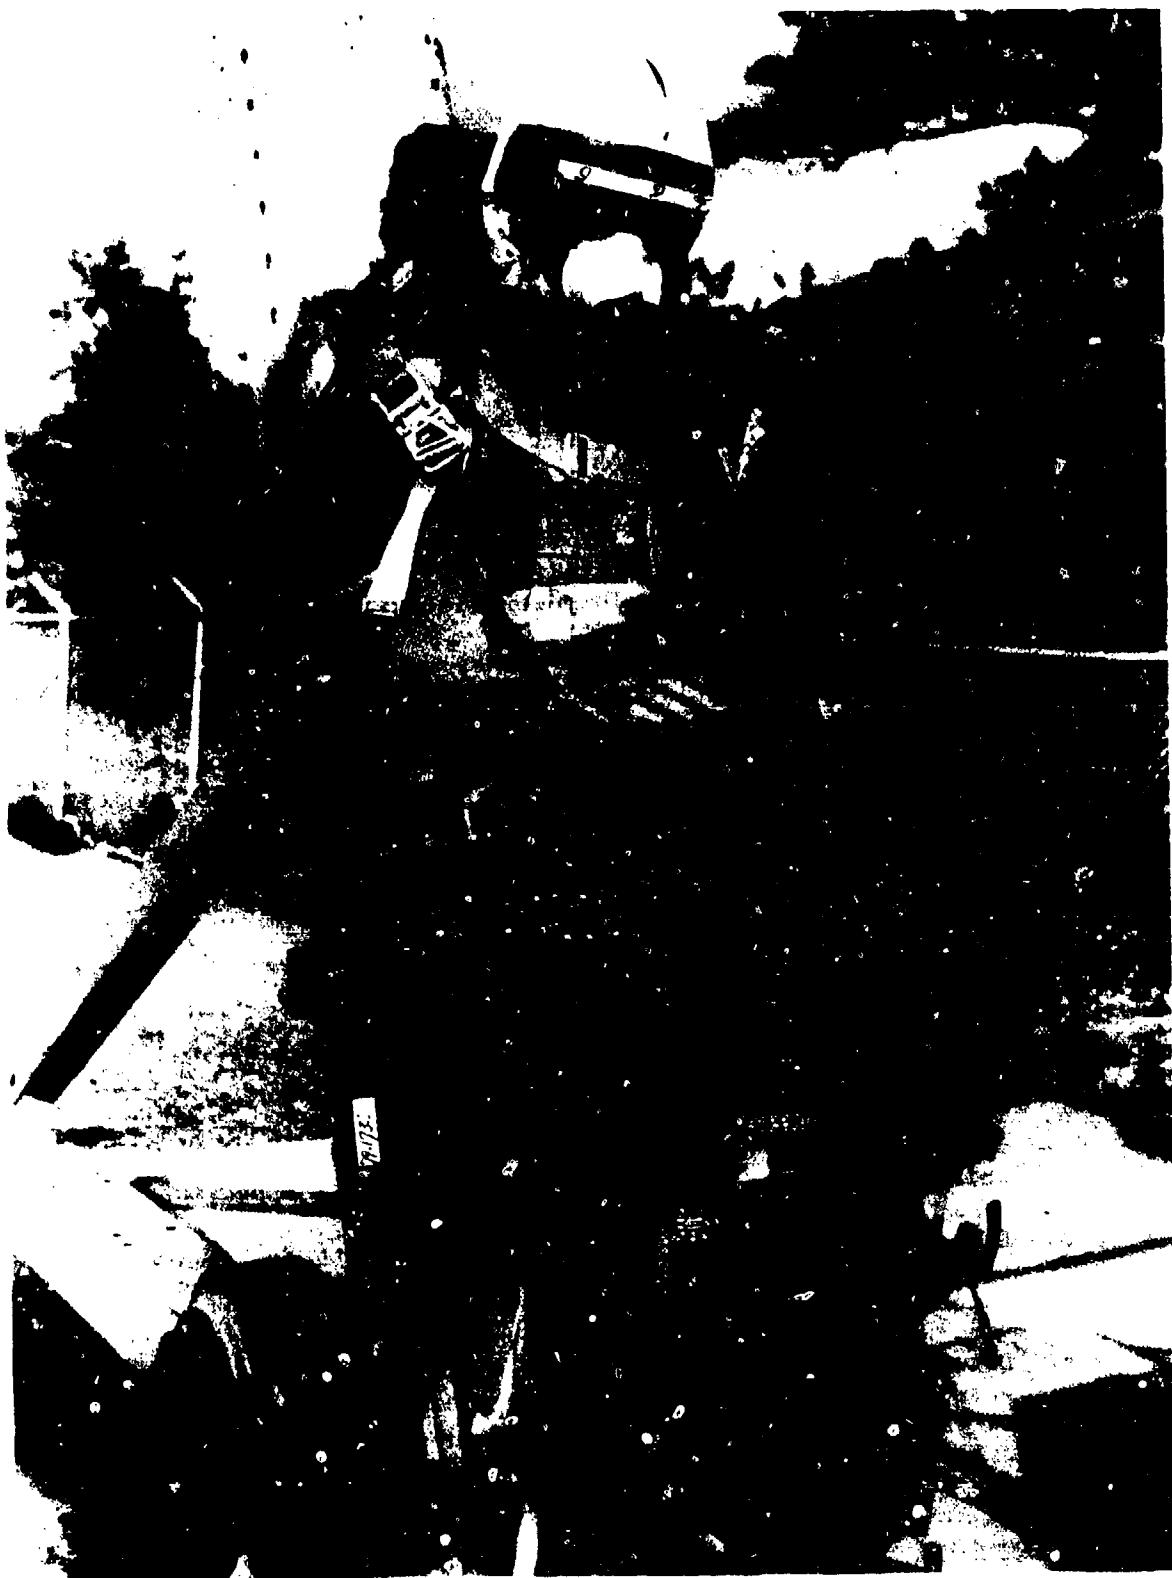
FIGURE 27 - Post Test Condition - 605 Knots Starboard Side

The right arm was perfectly retained in its original position (figure 27). The test however, was still considered very successful.
